# **The effectiveness of witnessed four-stage clearances following licensed asbestos removal**

Prepared by researchers at the  
**Health and Safety Executive**

**RR1218 (2025)**

**Research Report**

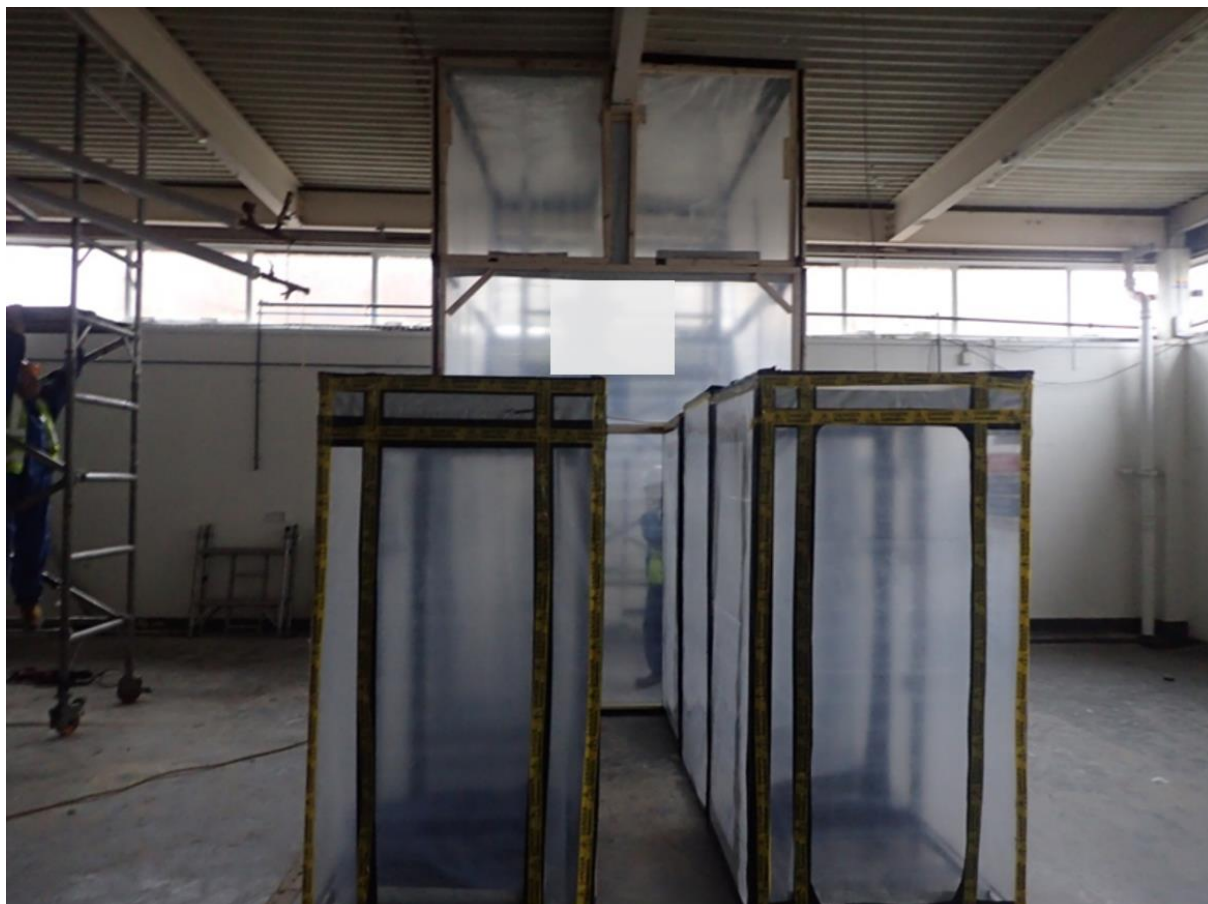
**Figure 1.** An asbestos removal enclosure with airlocks being constructed on a site visited by HSE scientists

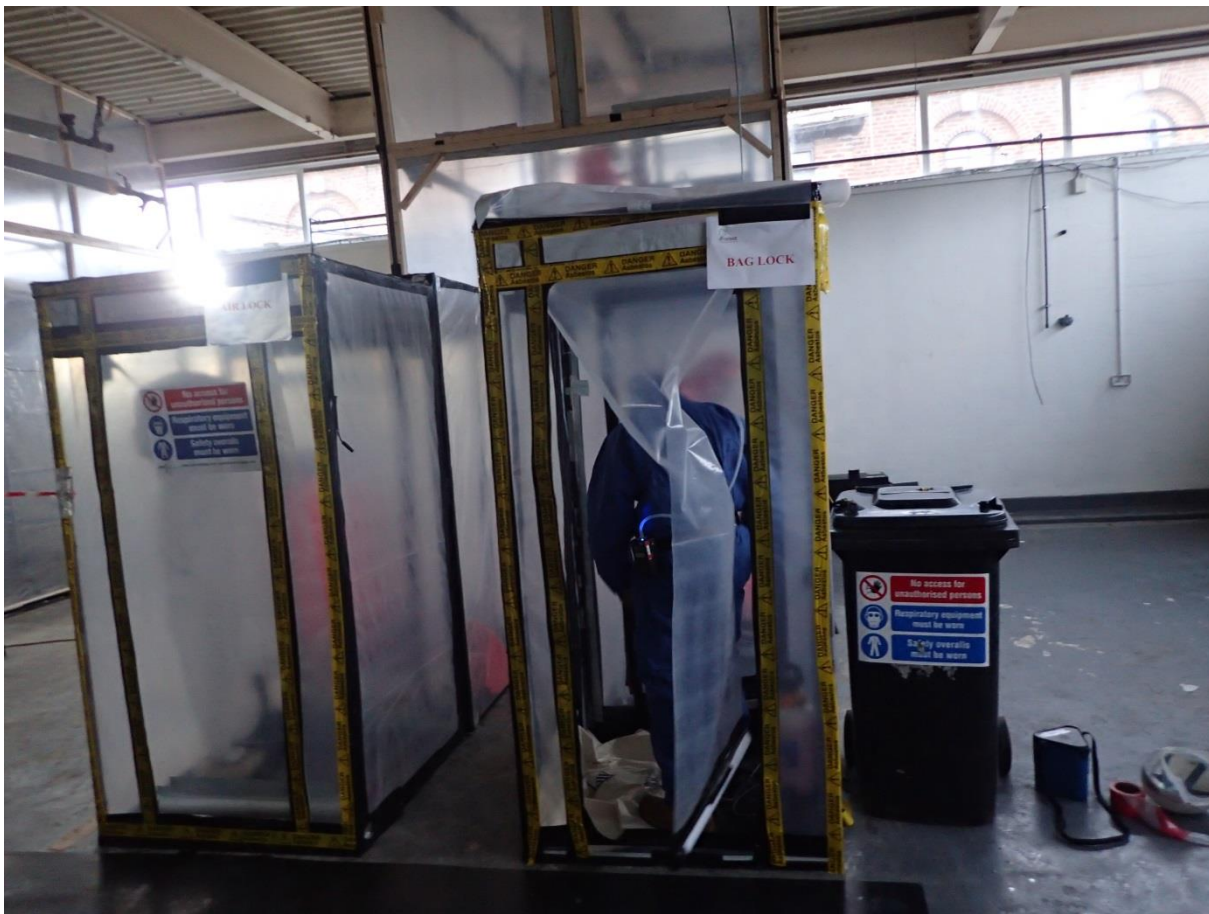
**Figure 2.** An asbestos removal worker wearing a sampling pump whilst removing waste from an enclosure

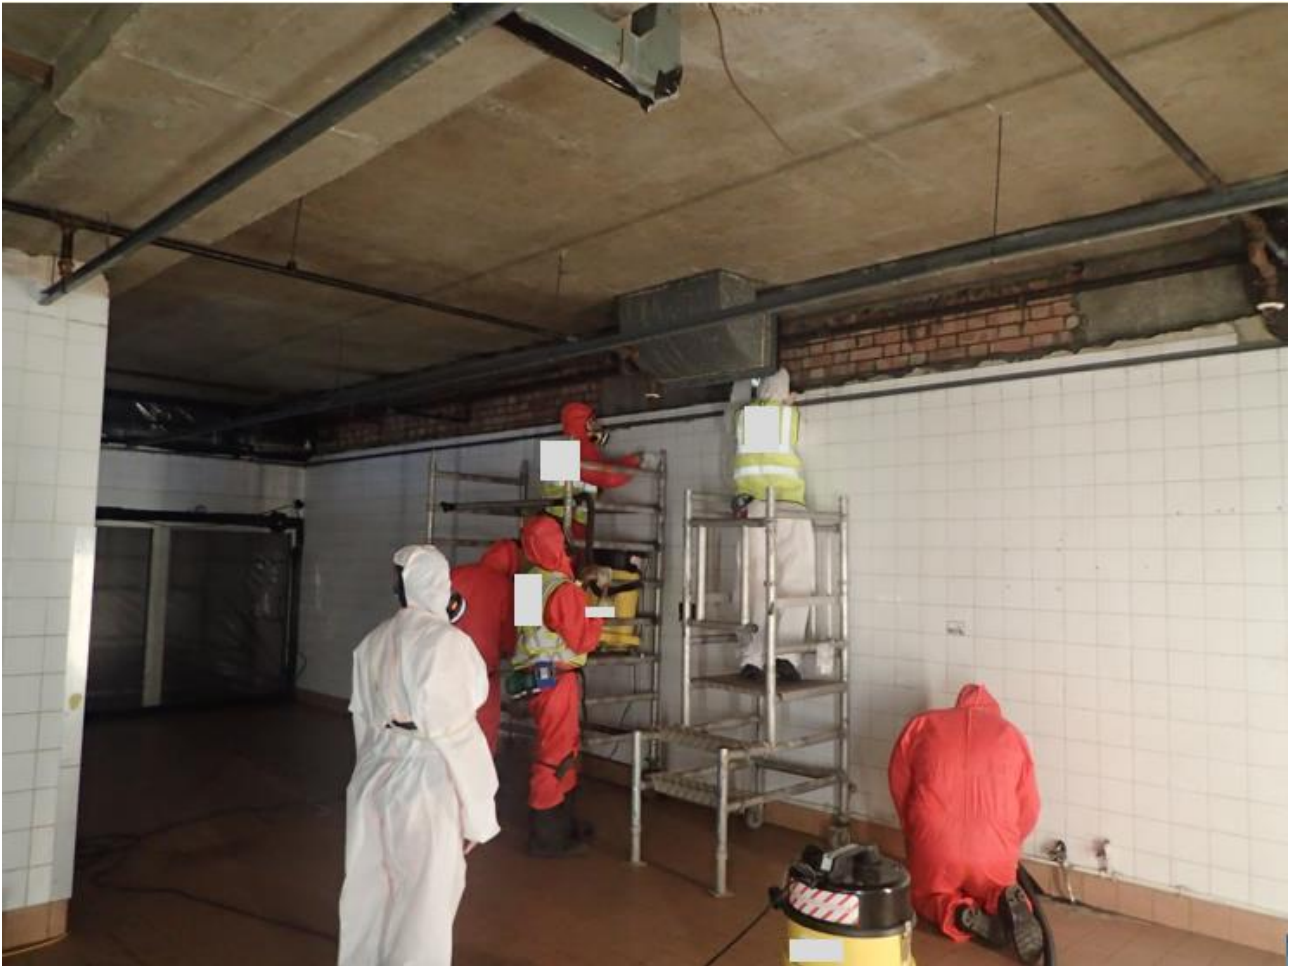
**Figure 3** Analyst and trainees (white coveralls) carrying out visual inspection accompanied by removal workers

Although the 4SC analysts were not witnessed directly carrying out cleaning at this stage, cleaning did take place during the visual inspection stage. On all sites at least one removal worker, and on occasion two or more, accompanied the 4SC analyst into the enclosure for the visual inspection (see Figure 3). This was to perform any minor cleaning required, as directed by the 4SC analyst. This practice is following guidance, however, due to the number of removal workers required, it would suggest that the enclosure was not clean enough. On some sites 4SC analysts remained in the enclosure whilst this minor cleaning was being conducted. This is not seen as good practice.

In four of the enclosures, the visual inspection duration was longer than one hour. Removal workers were also witnessed cleaning for most of the visual inspection time. This suggested that a full and proper final clean was not undertaken. The updated HSG 248 now requires a 10-minute limit on cleaning during visual inspection. Under these new criteria, all four visual inspections would have failed. It is understood that the removal workers may have just been 'keeping busy' whilst the inspection was being conducted but, in most cases, they were being directed by the 4SC analyst to clean areas. Section 4.5.2 covers 4SC analysts RPE usage choice and whether it was suitable for the length of time of visual inspections.
