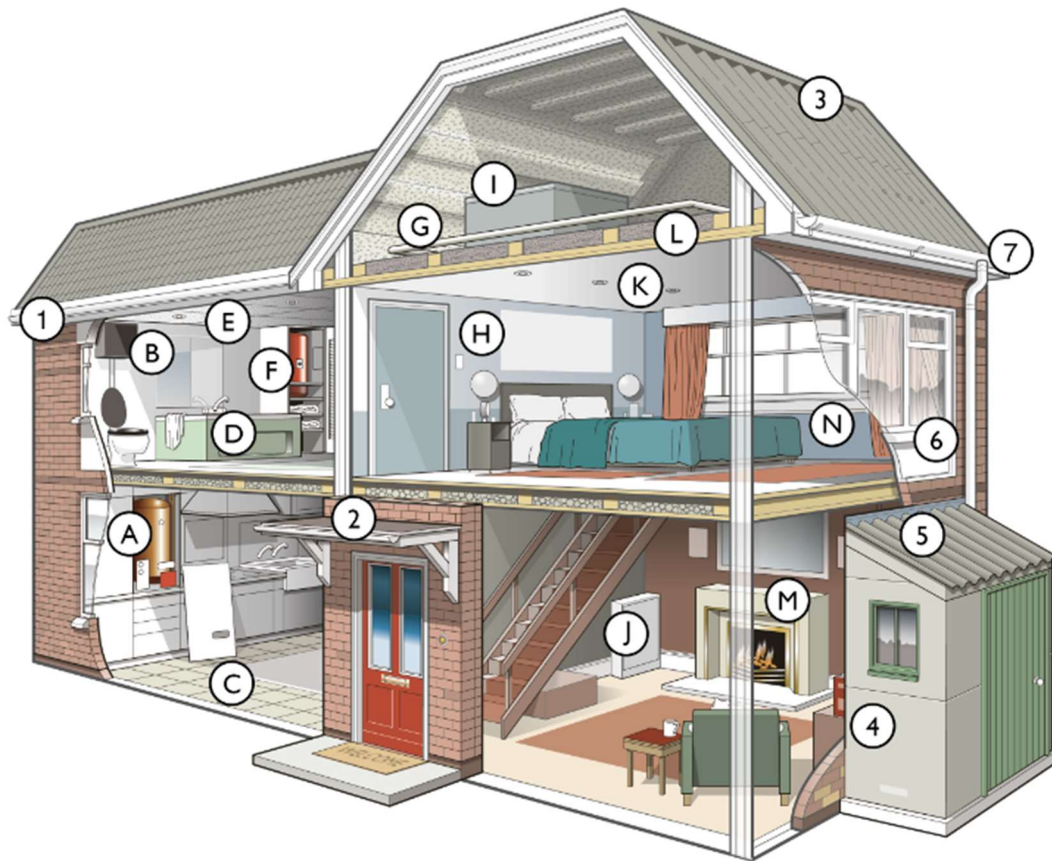
#### Inside:

- a) asbestos insulating board (AIB) around boiler
- b) toilet cistern
- c) vinyl floor tiles backed with asbestos paper and bitumen adhesive
- d) AIB or asbestos cement bath panels
- e) AIB ceiling tiles
- f) AIB airing cupboard and/or sprayed insulation coating boiler
- g) pipe lagging
- h) AIB partition wall
- i) asbestos cement water tank
- j) AIB behind fuse box
- k) textured decorative coating, for example Artex
- l) loose fill insulation
- m) AIB behind fire
- n) AIB or asbestos cement interior window panel

#### Outside:

- 1. AIB or asbestos cement soffits and fascias
- 2. roofing felt
- 3. asbestos cement roof tiles/slates
- 4. asbestos cement panels
- 5. profiled asbestos cement sheeting
- 6. AIB or asbestos cement exterior window panel
- 7. gutters and asbestos cement downpipes
